Diamond Linkage Upgrade

For the Stolle Ragsdale Bodymaker
April 2009

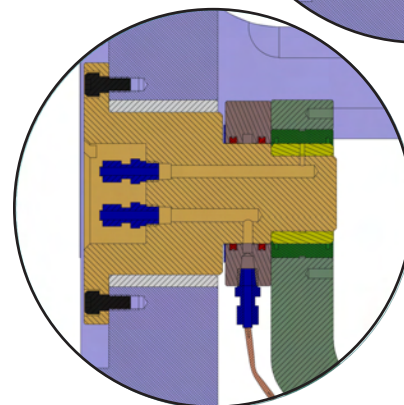
Previous ankle shaft assembly

In reviewing maintenance records of Ragsdale Bodymakers, the Stolle CMD Aftermarket team discovered that 70% of Diamond Linkage failures could be traced directly to failures in the ankle shaft bearing. Stolle has designed a new ankle shaft bearing assembly to prevent premature linkage failure and increase the time between maintenance intervals.
