Stolle Machinery Company, LLC
Stolle Advanced Technology Operations (SATO)

Technical Bulletin Number: 001

Necker (E-NCKR) Reform Head Proper Greasing and Maintenance Procedures

All Die Neckers using Reform Head Assembly Part Number 222160211

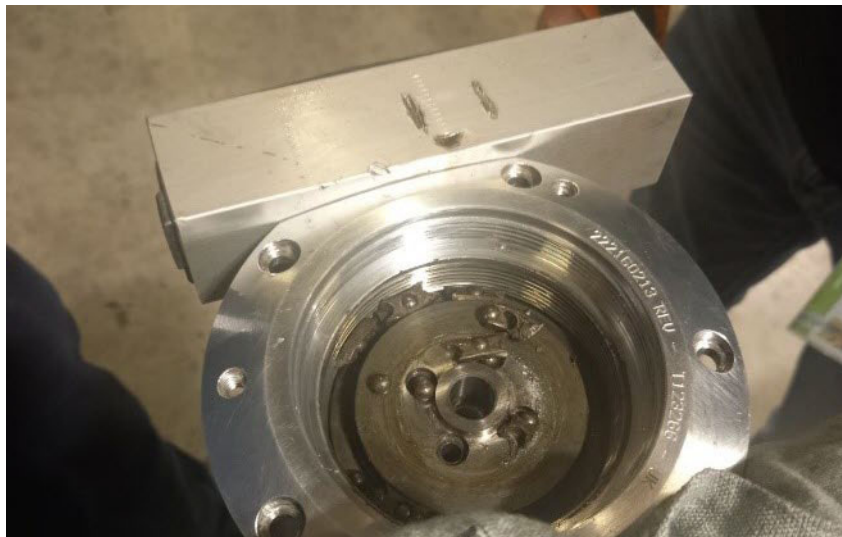
Lack of regular maintenance and greasing eventually causes the thrust bearings to generate heat and can result in bedding of the grease with metallic particulates. This can lead to failure of the thrust bearing seals, which further reduces grease volume. Refer to Figure 1-1. As this cycle continues, reformed CAN capability characteristics may decline until eventual failure of the thrust bearing occurs. At this stage no further operation of the Reformer/Necker is recommended until the Reform Heads are inspected and parts replaced and greased as necessary. Follow the procedure in paragraph 1.3, Correction to disassemble, clean, inspect, and lubricate the Reform Head Assemblies.

Figure 1-1. Necker Reform Head Failure

To properly maintain the Necker Reform Heads, perform the following procedure every month:

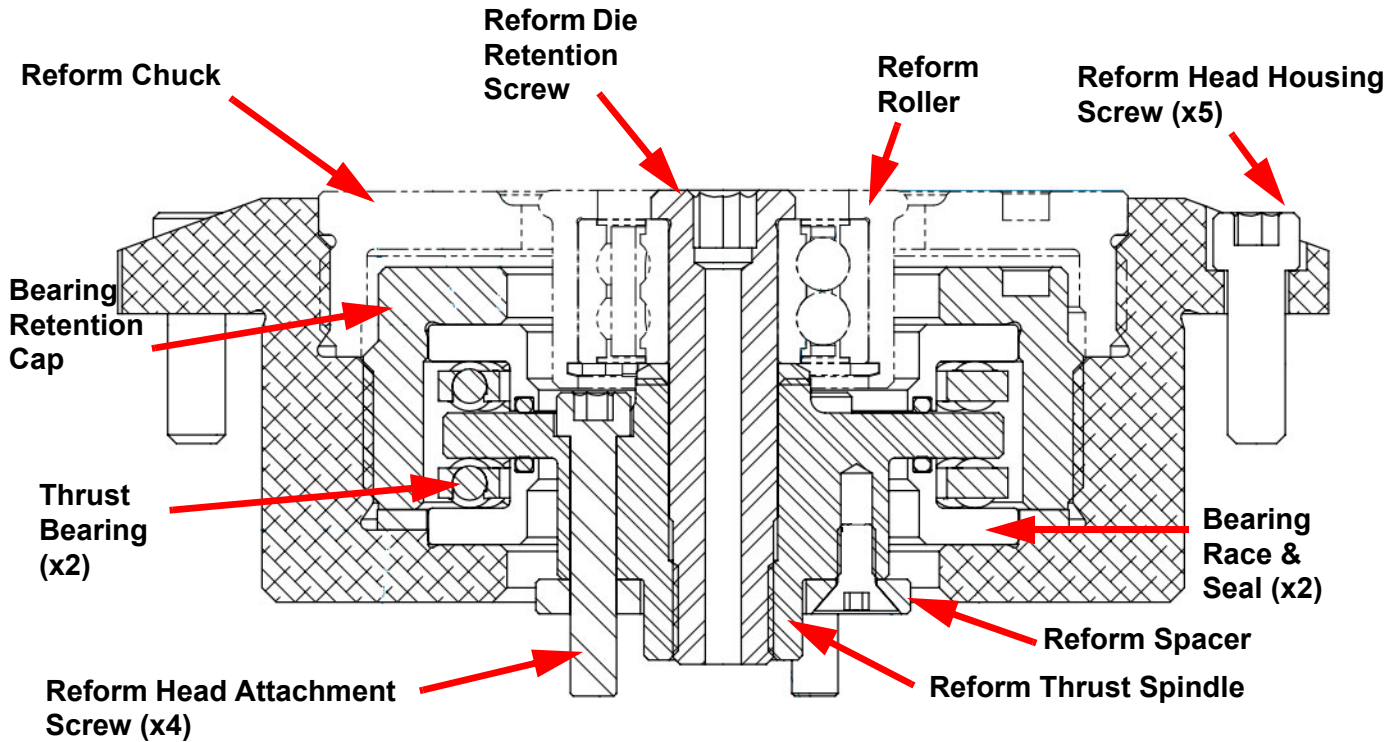
Figure 1-2. Reform Head Cross-section

1. Remove the Reform Chuck with the Reform Chuck spanner.
2. Loosen the Reform Die Retention Screw with a 1/4 inch hex tool, and remove the Reform Roller with the screw. Do not lose any spacers or shims at the base of the Reform Roller.
3. Loosen but do not remove the Bearing Retention Cap with the Reform Chuck spanner.

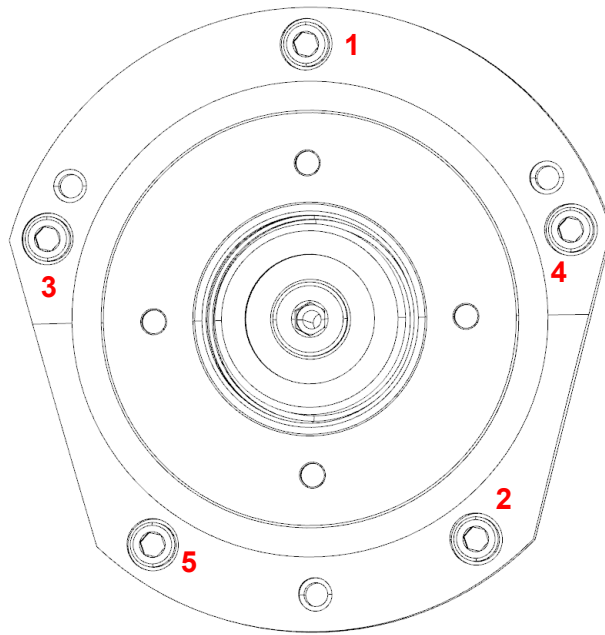
Figure 1-3. Reform Head Assembly Housing Screw Tightening Order

10. Reinstall the Reform Thrust Spindle, the two Thrust Bearings, the two Thrust Bearing Races, and the Bearing Retention Cap into the Reform Head hand tight using the Reform Chuck spanner.
11. Place the Reform Head back into position flush against the Disc.
12. To get the Reform Head Assembly to seat properly thread two attachment screws partially into the assembly. Slowly rock the unit back and forth while gently applying pressure until the threads on the screws align with the threads in the reform linkage.
13. Thread the remaining two attachment screws into place.
14. Tighten the four Reform Head attachment screws and torque to 5.7 ft/lbs (7.7 Nm).
15. Thread the five Reform Head housing screws hand tight. Torque the screws to 14 ft/lbs (19 Nm) in the order shown below:

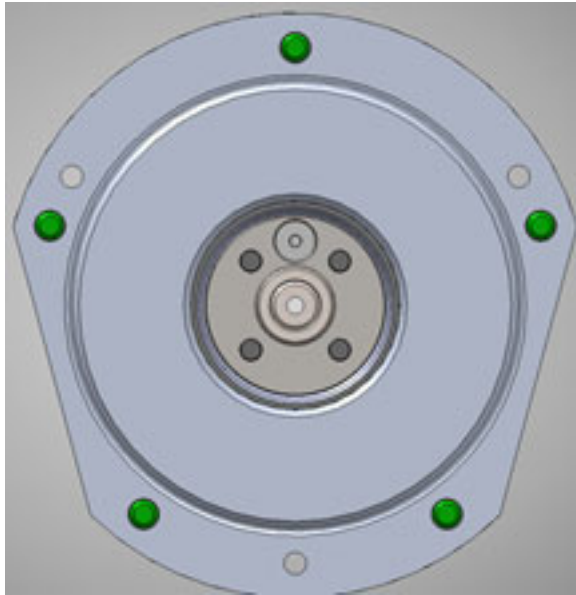
Figure 1-4. Original Reform Head Assembly

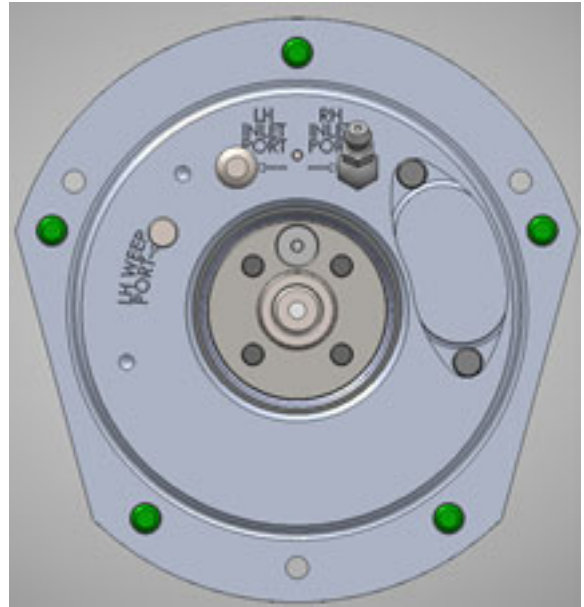
Figure 1-5. New Reform Head Assembly

From Q4 of 2022 a new Reform Head Assembly with grease port for easier access is available.

Spare Reform Head Assemblies are available for purchase under part number 222279752.
