Diamond Linkage Upgrade

For the Stolle Ragsdale Bodymaker
April 2009

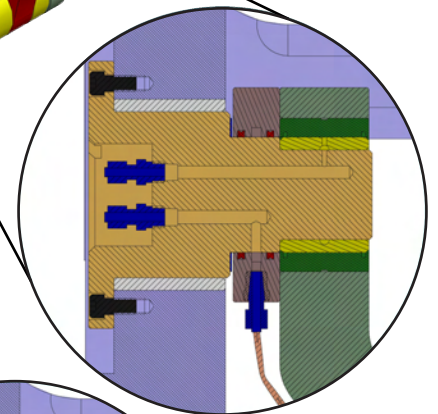
In reviewing maintenance records of Ragsdale Bodymakers, the Stolle CMD Aftermarket team discovered that 70% of Diamond Linkage failures could be traced directly to failures in the ankle shaft bearing. Stolle has designed a new ankle shaft bearing assembly to prevent premature linkage failure and increase the time between maintenance intervals.

The main component of the new design is a larger roller bearing for the ankle shaft joint. The bearing diameter has been increased by 13% and the width by 40%, which results in a 67% increase in its load carrying capacity.

Cutaway of upgraded ankle shaft assembly showing larger roller bearing and rocker link

An ankle shaft upgrade kit is available to retrofit existing Diamond Linkages to the new improved design (part number 222010513). The upgrade kit consists of:
