Diamond Linkage Upgrade

For the Stolle Ragsdale Bodymaker
April 2009

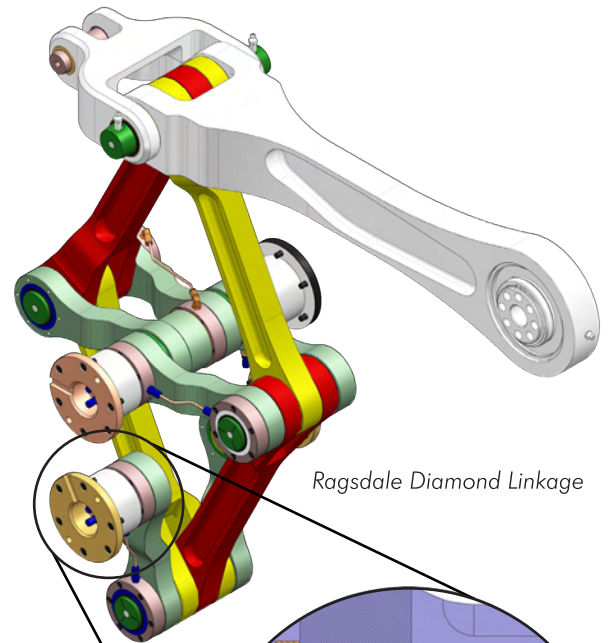
Ragsdale Diamond Linkage

In reviewing maintenance records of Ragsdale Bodymakers, the Stolle CMD Aftermarket team discovered that 70% of Diamond Linkage failures could be traced directly to failures in the ankle shaft bearing. Stolle has designed a new ankle shaft bearing assembly to prevent premature linkage failure and increase the time between maintenance intervals.

Cutaway of upgraded ankle shaft assembly showing larger roller bearing and rocker link

The main component of the new design is a larger roller bearing for the ankle shaft joint. The bearing diameter has been increased by 13% and the width by 40%, which results in a 67% increase in its load carrying capacity.

An ankle shaft upgrade kit is available to retrofit existing Diamond Linkages to the new improved design (part number 222010513). The upgrade kit consists of:
