Redesigned Bull Gear

for the Stolle 6-Color Rutherford Decorator

Technical Update 1110-1

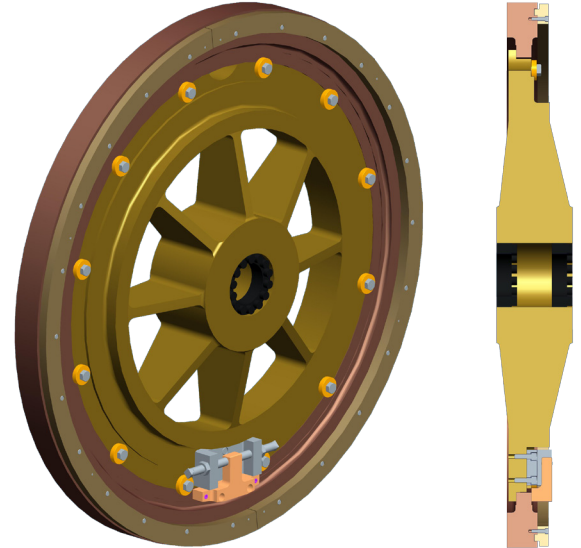
*Redesigned bull gear for the
6-Color Rutherford Decorator*

Stolle has redesigned the bull gear for a 6-color Rutherford Decorator to reduce vibration, improve registration and print quality. The existing one-piece bull gear has been replaced by a two-piece hub and gear design. The size of the hub has been increased to reduce the vibration in the system and reduce registration variation caused by this vibration.

The new design also includes an improved timing mechanism. The position of the gear can now be adjusted with respect to the hub, which will allow the customer to adjust the timing of the gear without loosening the hub on the main shaft. The new two piece design will also allow for faster replacement of the gear since the hub will not need to be removed.
